37. Országos Tudományos Diákköri Konferencia  
Had- és Rendészettudományi Szekció  
Budapest, 2025. április 22–24.  
Nemzeti Közszolgálati Egyetem  
Hadtudományi és Honvédtisztképző Kar

## **Analyzing the Effectiveness of School Security Measures in Rampage School Shootings**

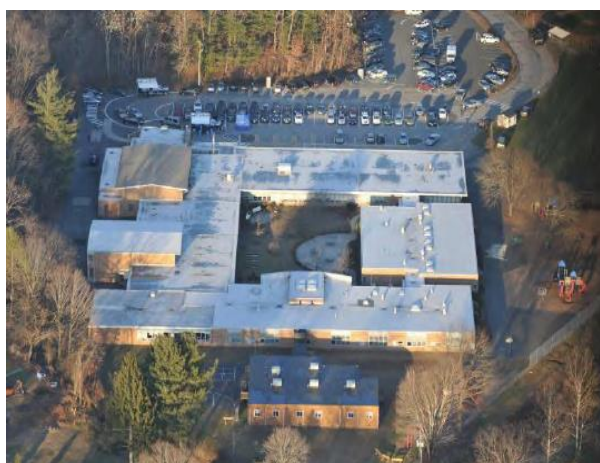
Figure A2. Perimeter Fence at Sandy Hook Elementary School (bottom right corner of the image) (*Appendix to Report A165*)

The first identified ineffective security measure in the Sandy Hook Elementary School shooting was the perimeter fence of the school (see figure A2 in Appendix A). The primary cause that made this security measure ineffective was the fact that this perimeter fence surrounded only the eastern and southern parts of the school grounds, leaving the northern and western sides of the school entirely unprotected (*Appendix to Report A121*). Consequently, the typical shortcoming that rendered this perimeter fence ineffective was determined to be an inherent flaw: a pre-existing limitation of the security measure, and therefore it was categorized into the (A) security measure-based shortcoming category.

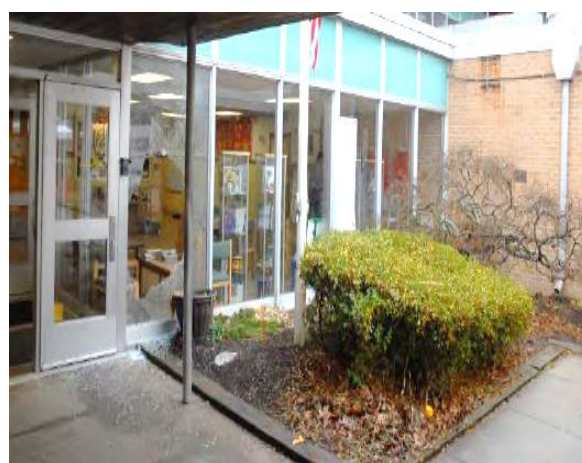
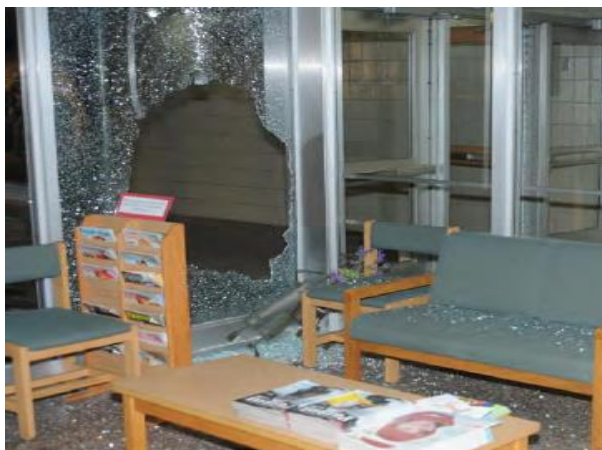
Figure A3. Destroyed Pane-Glass Window Outside Sandy Hook Elementary School (*Appendix to Report A167*)

Figure A4. Destroyed Pane-Glass Window  
Inside Sandy Hook Elementary School  
(Appendix to Report A171)

The second identified ineffective security measure was the pane-glass windows of the main entrance of the school (see figures A3 and A4 in Appendix A). This part of the building was constructed from six pane-glass windows, each measuring about "85.5 inches high and 49 inches wide." On the day of the shooting, the gunman entered the school building by shooting out one of these windows with an AR-15-style assault rifle (*Appendix to Report A126*). According to Sanjay Soni, this type of rifle fires high-velocity bullets, which have a muzzle velocity of at least 2,500 feet per second upon exiting the weapon. In general, the higher the muzzle velocity of a bullet, the greater the damage it causes with its striking power derived from kinetic energy ("Biting the Silver Bullet-10"). As Ernest E. Moore explains, the typical 5.56 mm bullet used by most AR-15-style assault rifles has a muzzle velocity of approximately 3,250 feet per second, which allows this projectile to express 1300-foot pounds of kinetic energy upon striking the target ("The Parkland shooter"). Therefore, the primary cause that

made the pane-glass windows ineffective was the shooter using a “Bushmaster Model XM15-E2S” semi-automatic rifle with “5.56 mm ammunition,” whereas the secondary cause was the window’s lack of bullet-resistant material (Report of the State’s Attorney 9, 18). The combination of these individual causes resulted in the formation of a “35.3 inches wide and 42.5 inches high” elliptical-shaped fracture in the pane-glass window, through which the perpetrator was able to enter the building’s interior (*Appendix to Report A126*). For this reason, the typical shortcoming that rendered the pane-glass window ineffective was determined to be its lack of resistance against the striking power of 5.56 mm bullets fired from an AR-15-style semi-automatic rifle, and consequently, it was classified into the (C) shooter-based shortcoming category.

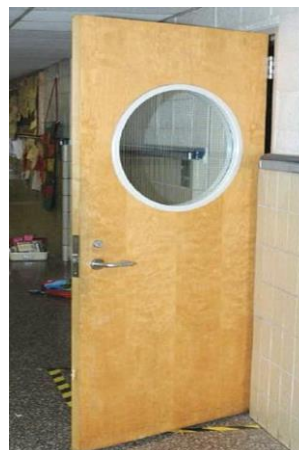
Figure A5. Wooden Interior Door at Sandy  
Hook Elementary School (Bates)

The fourth identified ineffective security measure was the interior doors of the school (see figure A5 in Appendix A). According to Lawrence J. Fennelly and Marianna A. Perry, “the function of a door in physical security is to provide a barrier at a point of entry or exit” (276). In addition, as the Johns Hopkins University Applied Physics Laboratory argues, in order for a door to be effective against active shooters, it must be bullet-resistant, that is, “capable of preventing penetration by a bullet fired from a firearm” (3-32). However, in the school’s north hallway, where the shooting occurred, three wooden interior doors were visibly penetrated by projectiles shot from the shooter’s firearm (*Appendix to Report A130-A131*). For this reason, the primary cause that made this security measure ineffective was the shooter using a “Bushmaster Model XM15-E2S” semi-automatic rifle with “5.56 mm ammunition,” whereas the secondary cause was the interior doors’ lack of bullet-resistant material (*Report of the State’s Attorney* 9, 18). Based on this observation, the typical shortcoming that rendered the interior doors ineffective was determined to be their lack of resistance against the striking power of 5.56 mm bullets fired from an AR-15-style semi-automatic rifle, and consequently, they were classified into the (C) shooter-based shortcoming category.

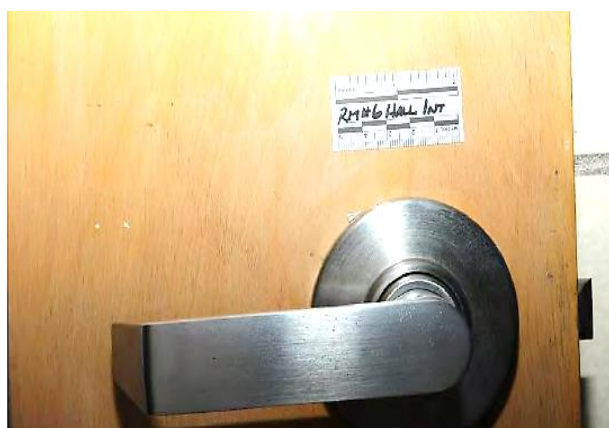
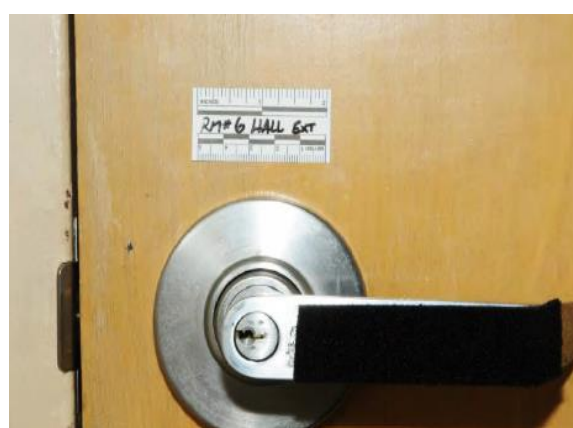
Figure A6. Interior Door Lock (Classroom  
Side) (Appendix to Report A178)

Figure A7. Interior Door Lock (Hallway  
Side) (Appendix to Report A178)

The fifth identified ineffective security measure was the interior door locks of the school (see figures A6 and A7 in Appendix A), which could be locked only from the outside (hallway side) with a key (*Report of the State's Attorney* 18). As James M. Edgar et al. explain, key-operated mechanical locks utilize a unique configuration of internal impediments that allow the locking mechanism to work only when these inside barriers are properly arranged with a key (139). However, as the Johns Hopkins University Applied Physics Laboratory argues, in order to achieve the effective operation of door locks in schools, it is important to introduce policies outlining security procedures (e.g., locking interior doors), which are followed by school personnel in active shooter events (3-7, 3-8). For example, in the Sandy Hook Elementary School shooting, the gunman was able to enter classrooms 8 and 10 only because their doors were left unlocked by school personnel at the time of the attack (*Report of the State's Attorney* 20-21). Therefore, the primary cause that made this security measure ineffective was school personnel's noncompliance with lockdown procedures outlined in the school's "Emergency Response Plan" that required classroom doors to be locked in active shooter events (*Appendix to Report* A145-146). Consequently, the typical shortcoming that rendered the interior door locks ineffective was determined to be the negligent locking of classroom doors by school personnel, and therefore the interior door locks were categorized into the (B) school personnel-based shortcoming category.

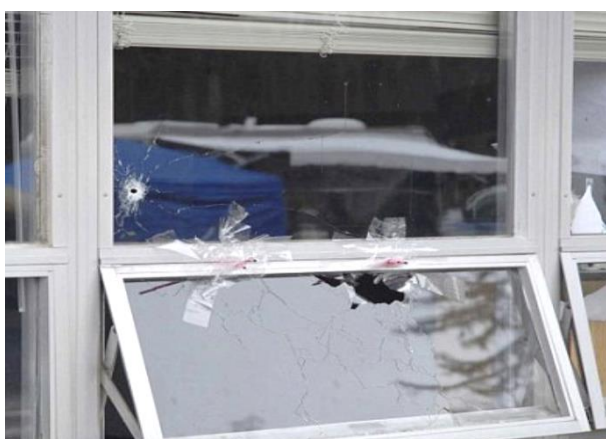
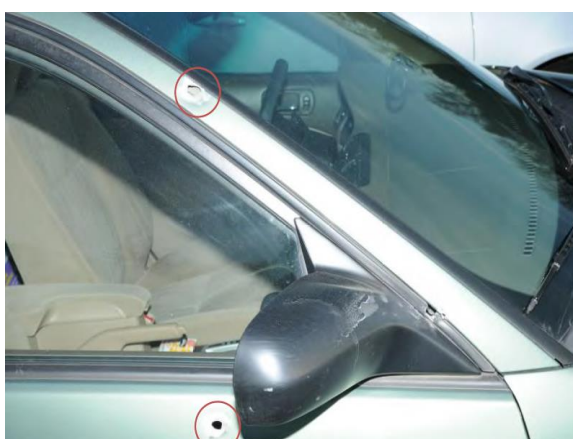
Figure A8. Penetrated Window of  
Classroom 10 at Sandy Hook Elementary  
School (Bates)

Figure A9. Bullet Penetrations to a Car in  
Sandy Hook Elementary School's Parking  
Lot (Appendix to Report A176)

The sixth identified ineffective security measure was the classroom windows of the school (see figures A8 and A9 in Appendix A). On the north side of the school building, eight classroom windows, each containing four panes of glass, were located with a direct view to the school's parking lot (*Appendix to Report* A133). When the shooter was inside classroom 10, nine bullets fired from his weapon penetrated the window of this classroom and, after flying across the school grounds, stroked three vehicles in the parking lot (*Report of the State's Attorney* 20-21; *Appendix to Report* A120). Consequently, the primary cause that made the classroom windows ineffective was the shooter using a "Bushmaster Model XM15-E2S" semi-automatic rifle with "5.56 mm ammunition," whereas the secondary cause was the window's lack of bullet-resistant material (*Report of the State's Attorney* 9, 18). The combination of these individual causes, in addition to destroying the window in classroom 10, posed a significant threat to evacuating people who were near the parking lot at the time the stray bullets hit the cars (*Report of the State's Attorney* 13). Based on this observation, the typical shortcoming that rendered the classroom windows ineffective was determined to be their lack of resistance against the striking power of 5.56 mm bullets fired from an AR-15-style semi-automatic rifle, and therefore they were classified into the (C) shooter-based shortcoming category.

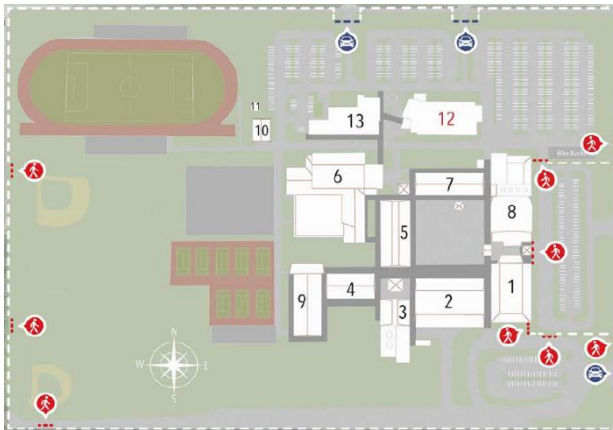
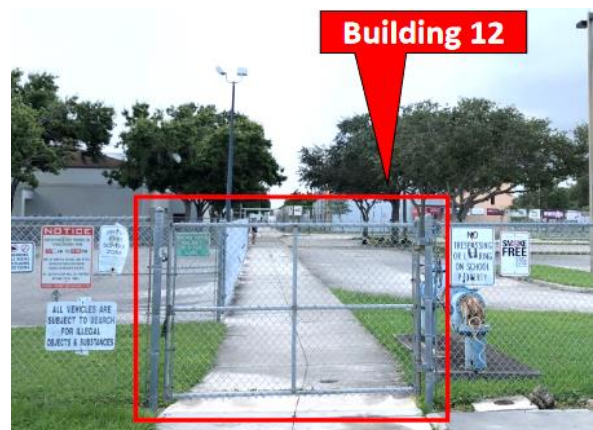
Figure B3. Pedestrian Gates at Marjory Stoneman Douglas High School (*Marjory Stoneman Douglas 41*)

Figure B4. Pedestrian Gate Used by the Shooter at the Marjory Stoneman Douglas High School Campus (Gualtieri, Bob)

The first identified ineffective security measure in the Marjory Stoneman Douglas High School shooting was the pedestrian gates of the school (see figures B3 and B4 in Appendix B). The campus had nine pedestrian gates, but only six of them on the east part of the school grounds were actively used by students and school personnel. On the day of the shooting, these pedestrian gates were opened by a campus monitor at 2:15 p.m. as a preparation for releasing students at 2:40 p.m., the time when school days regularly ended. However, at 2:19 p.m., the shooter, by exploiting these open and unsupervised gates, was able to enter the school grounds (Marjory Stoneman Douglas 40-42). For this reason, the primary cause that made this security measure ineffective was the fact that all six pedestrian gates on the east side of the campus remained unstaffed after being opened to release students at the end of the school day, which allowed the gunman to enter the school grounds unimpeded. Therefore, the typical shortcoming that rendered these pedestrian gates ineffective was determined to be their negligent supervision by campus monitors, and as a result, they were categorized into the (B) school personnel-based shortcoming category.

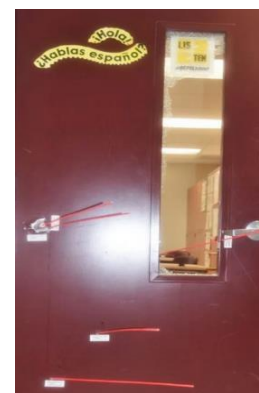
Figure B6. Interior Door of Building 12 at Marjory Stoneman Douglas High School (Schachter, Max)

The seventh identified ineffective security measure was the interior doors of Building 12 (see figure B6 in Appendix B), which were constructed of metal and had an 8-inch-wide pane-glass window (*Marjory Stoneman Douglas* 44). However, during the attack, the gunman, by shooting out these built-in windows, was able to target and shoot individuals inside the locked classrooms (*Marjory Stoneman Douglas* 25). Consequently, the primary cause that made this security measure ineffective was the shooter using a “Smith and Wesson model MP-15” semi-automatic rifle (*Marjory Stoneman Douglas* 262) with, as Christina Vazquez and Andrea Torres observe, 5.56 and .223mm ammunition, whereas the secondary cause was the interior doors’ lack of bullet-resistant material (“Parkland school shooting”). The combination of these individual causes resulted in the destruction of the built-in windows of the doors of classrooms 1213, 1214, 1216, 1231, and 1234, inside of which a total of eighteen individuals were shot by the shooter (*Marjory Stoneman Douglas* 25-31). For this reason, the typical shortcoming that rendered the interior doors ineffective was determined to be their lack of resistance against the striking power of 5.56 and .223mm bullets fired from an AR-15-style semi-automatic rifle, and therefore they were categorized into the (C) shooter-based shortcoming category.

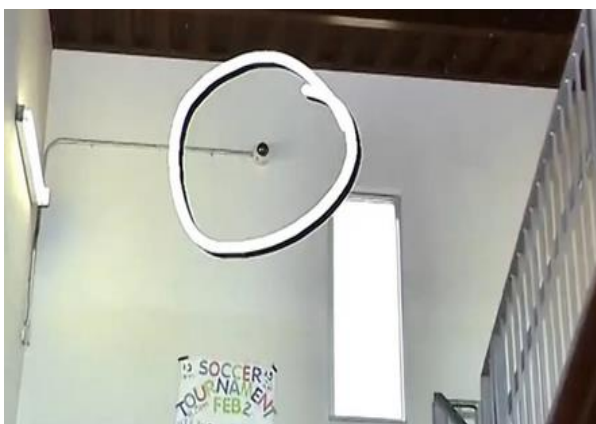
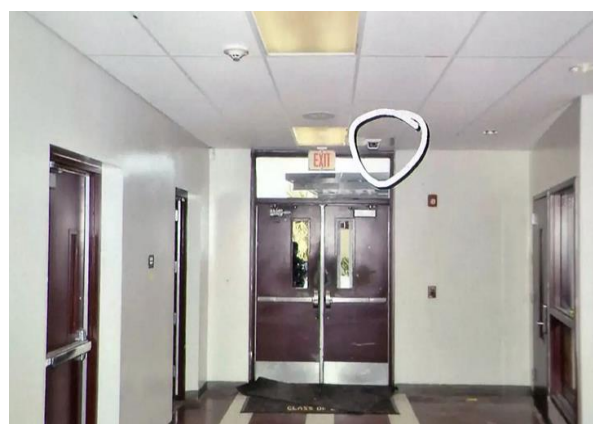
Figure B8. Security Camera in Building 12's Stairwell at Marjory Stoneman Douglas High School (Algar, Selim)

Figure B9. Security Camera in Building 12's Hallway at Marjory Stoneman Douglas High School (Algar, Selim)

The tenth identified ineffective security measure was the security cameras in Building 12 (see figures B8 and B9 in Appendix B). Inside the building, thirteen motion-activated security cameras were installed on the ceilings: three on the east and west parts of the hallways and two in each stairwell (*Marjory Stoneman Douglas* 45). However, the primary cause that made these security cameras ineffective was their delayed recording capabilities, which significantly hindered the law enforcement response to the shooting by creating the false illusion that the shooter was still in the hallways when the first responding officers entered Building 12 (*Marjory Stoneman Douglas* 168). Based on this observation, the typical shortcoming that rendered the security cameras ineffective was determined to be an inherent flaw: a pre-existing deficiency of the security measure, and as a result, they were classified into the (A) security measure-based shortcoming category.

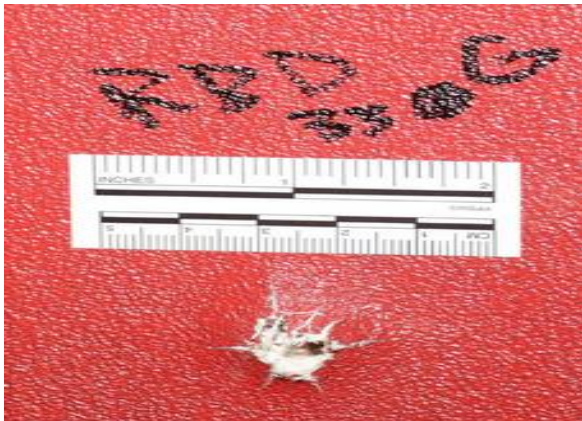
Figure C6. Penetrated Interior Wall of Classroom 109 (Cardenas, Natalie, et al.)

The fourth identified ineffective security measure was the interior walls of the West Building (see figure C6 in Appendix C). These walls of the building were constructed of drywall/sheetrock, a building material highly vulnerable to bullet penetration (U.S. Department of Justice 93). Therefore, when the shooter was rapidly firing his weapon inside classrooms 111 and 112, some of the bullets passed through multiple sheetrock panels between classrooms 112, 111, and 110 and injured people in classroom 109 (Investigative Committee 48, 52). Consequently, the primary cause that made the interior walls ineffective was the shooter using a "Daniel Defense DDM4 V7" semi-automatic rifle with "5.56 mm" ammunition, whereas the secondary cause was the sheetrock's lack of bullet-resistant material (Investigative Committee 35). The combination of these individual causes not only resulted in injuries from striking bullets inside classroom 109, but the stray projectiles exiting classrooms 111 and 112 also posed a significant threat to all people inside the West Building (U.S. Department of Justice 93). For this reason, the typical shortcoming that rendered the interior walls ineffective was determined to be their lack of resistance against the striking power of 5.56 mm bullets fired from an AR-15-style semi-automatic rifle, and consequently, they were classified into the (C) shooter-based shortcoming category.

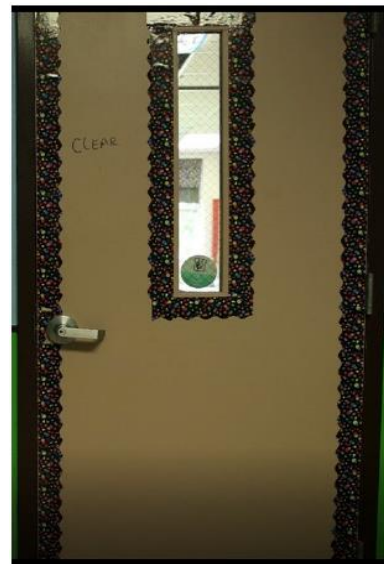
Figure C7. Interior Door and Lock of the West Building at Robb Elementary School (ALERRT 11)

The fifth identified ineffective security measure was the interior door locks of the West Building, which could be locked only from the outside (hallway side) with a key (see figure C7 in Appendix C) (U.S. Department of Justice 341). The primary cause that made this security measure ineffective was school personnel's noncompliance with the school's "Campus Safety Plan," which required interior doors to be locked at all times during the school day (U.S. Department of Justice 344). For example, on the day of the shooting, of the 19 rooms in the West Building, eight were found to be open by responding law enforcement officers during the building's evacuation (U.S. Department of Justice 345). In addition, the secondary cause was the negligent maintenance of interior door locks by school personnel. For instance, problems with the locking mechanism of classroom 111 were reported to school administrators a few months prior to the shooting; nevertheless, lacking a written maintenance request submitted, the faulty lock had never been repaired (Investigative Committee 70-71). Furthermore, the tertiary cause was school personnel's failure to check whether the interior doors of the building were properly locked during the lockdown. For example, the teacher in classroom 111, not receiving the lockdown alert on his phone, neither checked whether that classroom door was locked nor did he lock the shared interior door between classrooms 111 and 112, which ultimately allowed the shooter access to both classrooms, inside of which nineteen students and two teachers were murdered (Investigative Committee 71; U.S. Department of Justice xii). Consequently, the typical shortcoming that rendered the interior door locks ineffective was determined to be school personnel's noncompliance with the school's security policies and procedures, and therefore the interior door locks were classified into the (B) school personnel-based shortcoming category.

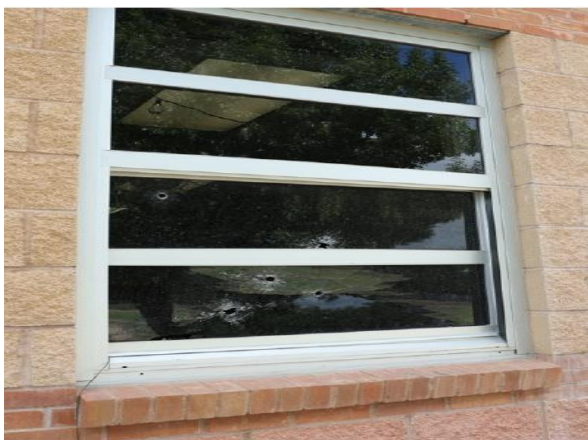
Figure C8. Penetrated Classroom Window of the West Building at Robb Elementary School (ALERRT 12)

The sixth identified ineffective security measure was the classroom windows of the West Building (see figure C8 in Appendix C). These windows were made of tempered glass (ALERT 11), which, as the Johns Hopkins University Applied Physics Laboratory explains, is a type of safety glass that, when fractured, crumbles into small, blunt-edged pieces rather than sharp chunks capable of cutting (3-33). On the day of the shooting, the window of classroom 102 was destroyed from the outside when the shooter fired at the building's exterior wall, whereas the window of classroom 111 was penetrated from the inside when the perpetrator was rapidly shooting in classrooms 111 and 112 (Investigative Committee 45; ALERT 12). Therefore, the primary cause that made the classroom windows ineffective was the shooter using a "Daniel Defense DDM4 V7" semi-automatic rifle with "5.56 mm" ammunition, whereas the secondary cause was the windows' lack of bullet-resistant material (Investigative Committee 35). For this reason, the typical shortcoming that rendered these windows
