## MODELLING OF SENTAB TYPE HIGH PRESSURE WATER PIPES AFTER DETERIORATION

György L. Balázs, Olivér Attila Czoboly, Éva Lubláy, Péter Zimmer

**10th CCC Congress**  
**LIBEREC 2014**  
Proceedings

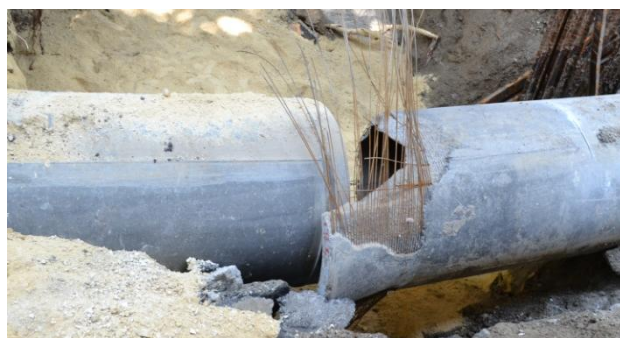
In 2012, when a 1000 mm diameter Sentab water pipe failed, and because of the high pressure water leakage, a 15 meter wide and several meters deep hole was created (Fig. 1). Parts of the road pavement were carried away 20-50 meters by the water.

**Fig. 1** The failure of Sentab type water pipe in 2012
